Federal Aviation Administration

Memorandum

Subject: Response to OSC Request for Supplemental Information/Supporting Documentation DI-18-4555, Detroit Metropolitan Airport (DTW)

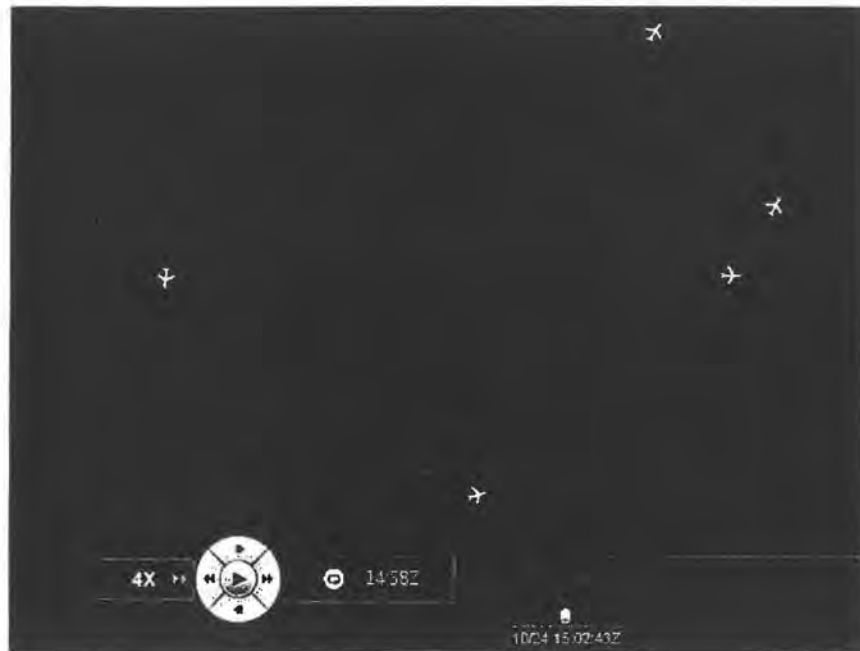
**GJS6251 WAS NOT ABLE TO PICK UP THE LOCALIZER (RWY 22R Y)
DURING PRM APPROACHES.**

PULLED OFF FINAL AND RE-SEQUENCED TO RWY 22L

**GJS6251 turning final, trying to pickup the RWY 22R
Localizer, about 22-24 miles out (10/24/2015)**
(DAL1242, A319 turning from TWY Alpha to TWY Quebec)

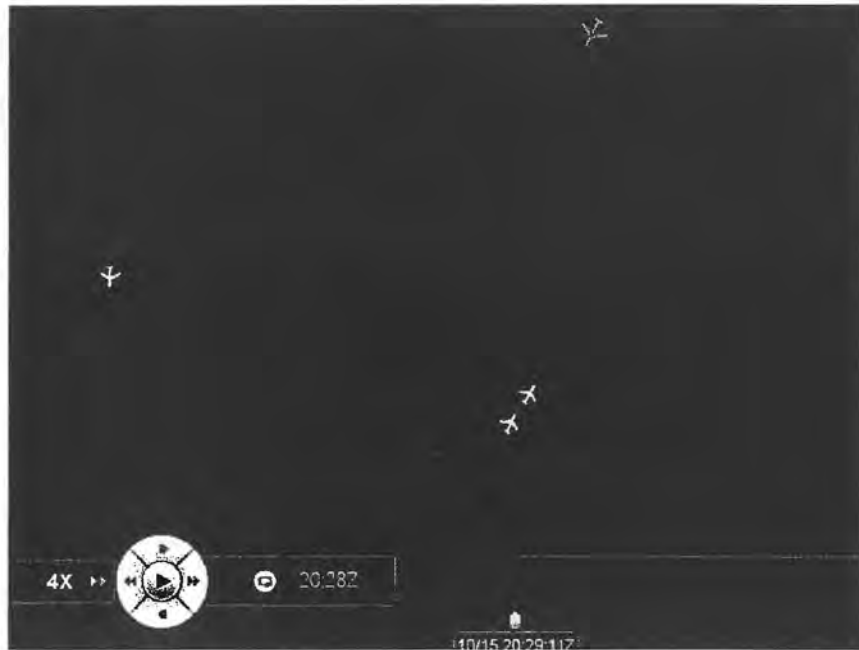
**ASQ5285 REPORTED THAT THEY HAD THE LOCALIZER DIALED UP
WAS NOT RECEIVING THE LOCALIZER. (RWY 22R Y)
ASQ5285 WAS ON A VISUAL APPROACH TO RWY 22R**

**ASQ5285, visual approach, turning about a 10 mile final RWY 22R
(10/15/2015)**

(DAL2508, B739 turning from TWY Alpha to TWY Quebec)

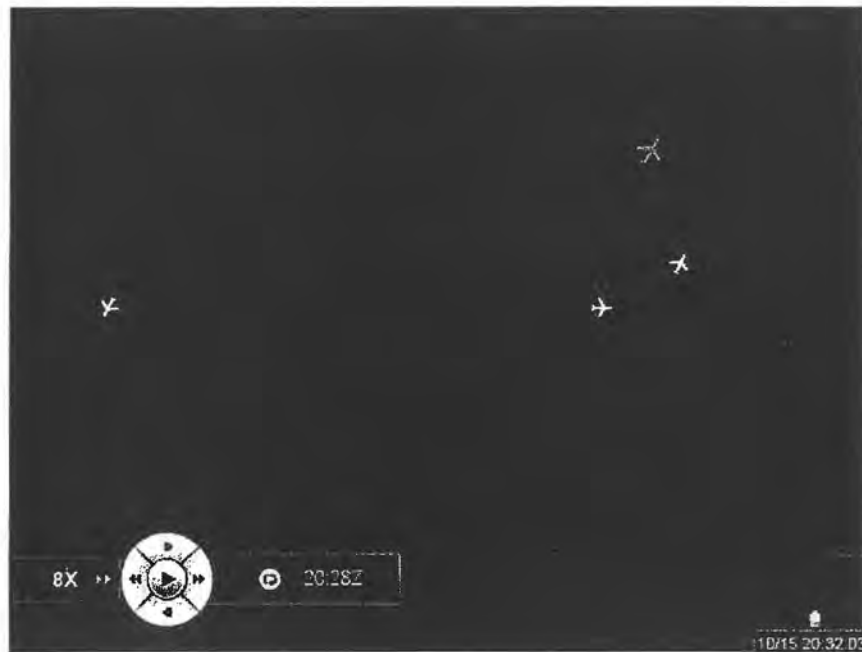
ASQ5285 on about a 5 mile final RWY 22R (10/15/2015)
(SKW4666, CRJ2 turning from TWY Alpha to TWY Quebec)

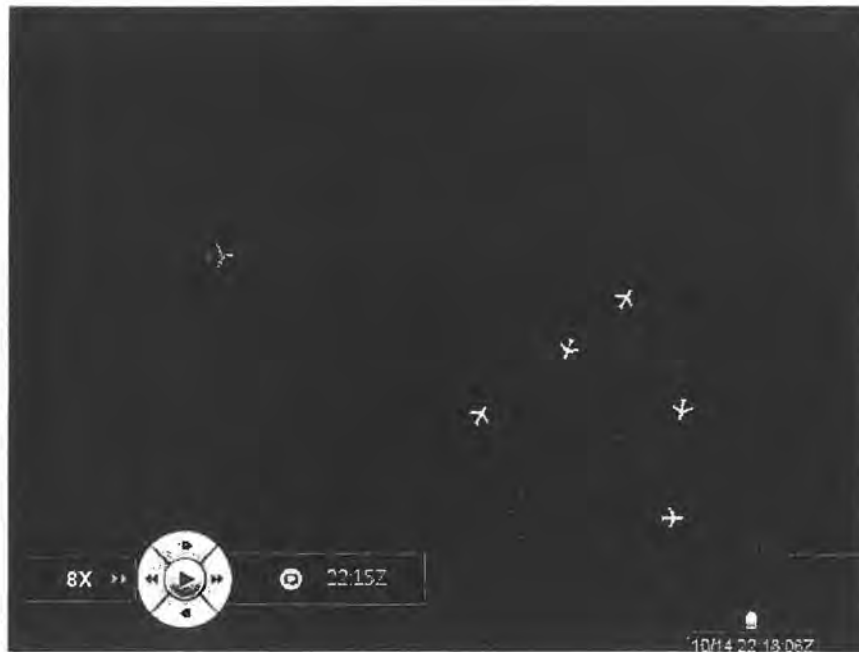
**PILOT STATED THAT THEY HAD 111.75 DIALED INTO BOTH RADIOS
AND NOTHING CAME UP**

FLG3661 WAS ON A VISUAL APPROACH RWY 04L

FLG3661 joining RWY 04L Localizer about 17 mile final (10/14/2015)
(DAL53, B757 clearing RWY 04L and turning south on TWY Alpha from TWY A-8)

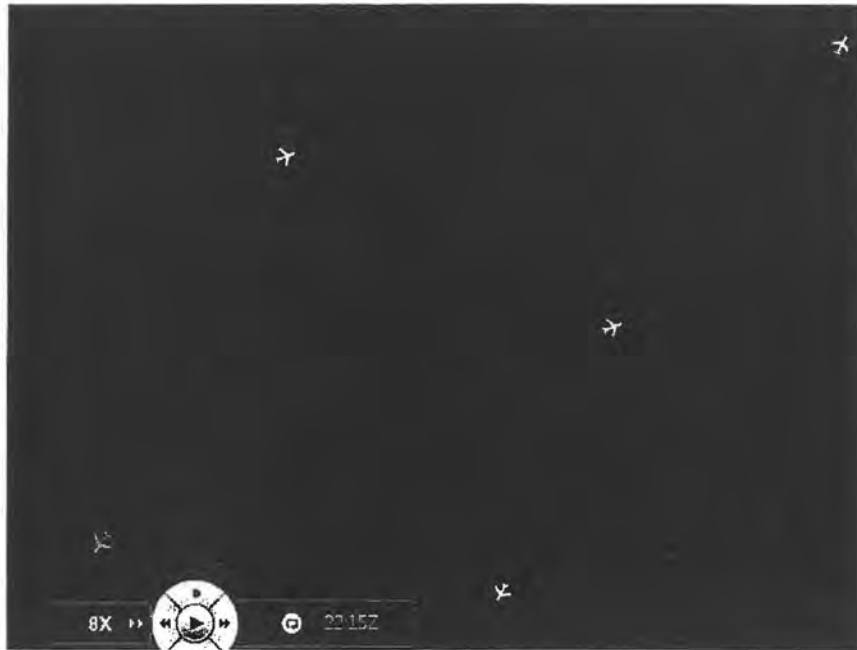
FLG3661 on about a 9 mile final RWY 04L (10/14/2015)
(DAL1645, A319 clearing RWY 04L and turning south on TWY Alpha from TWY A-8)

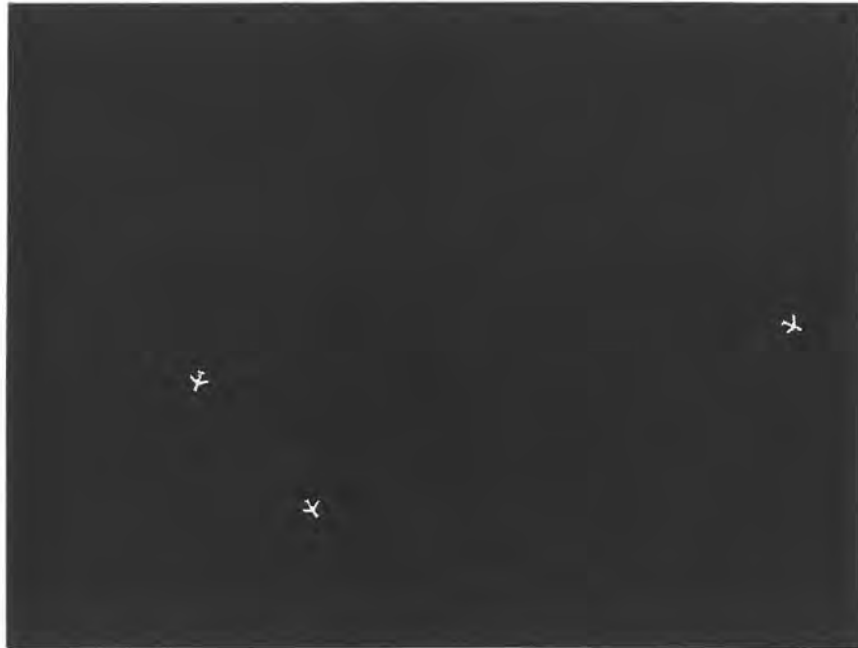
**GJS6187 RWY 22R ILS "Y" APPROACH
ADVISED DTW ATCT THAT THEY DID NOT
THINK THAT THEY WERE LINED UP RIGHT**

GJS6187 on about a 21 mile final RWY 22R (10/13/2015)
(TCF3394, E145 turning from TWY Alpha to TWY Quebec)

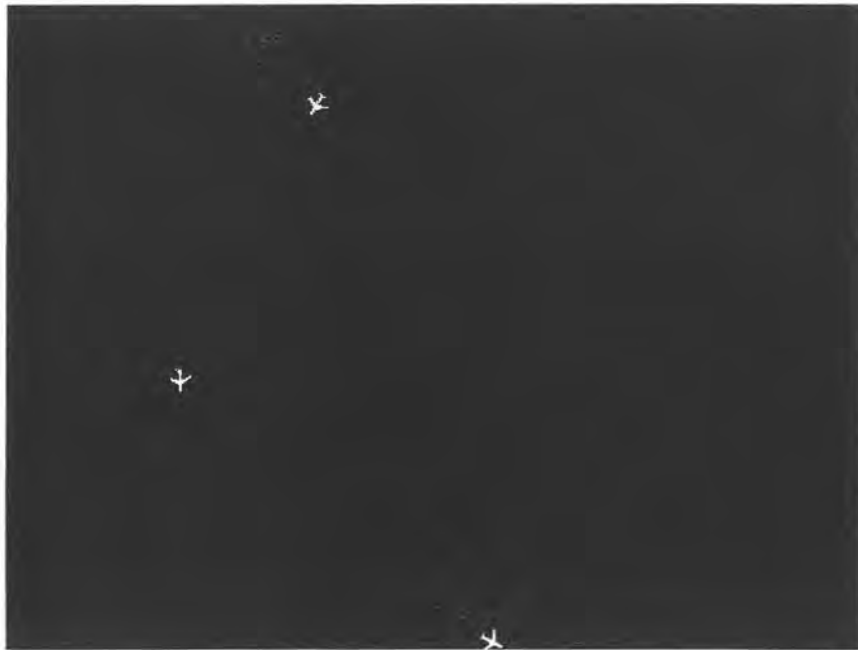
GJS6187 on about a 16 mile final RWY 22R (~10/13/2015)
(DAL1627, B712 turning from TWY Alpha to TWY Quebec)

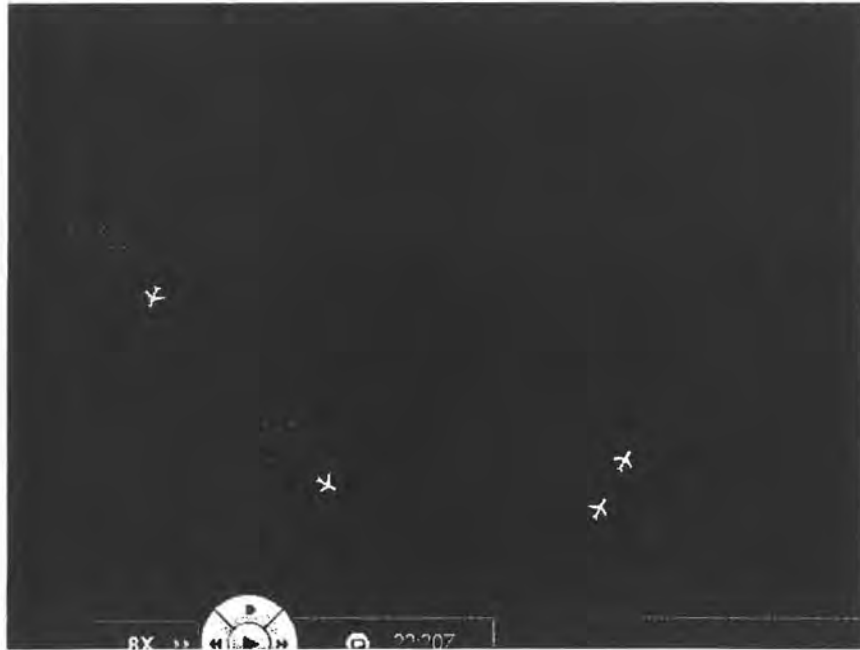
GJS6187 on about a 12 mile final RWY 22R (10/13/2015)
(FLG3689, CRJ2 turning from TWY Alpha to TWY Quebec)

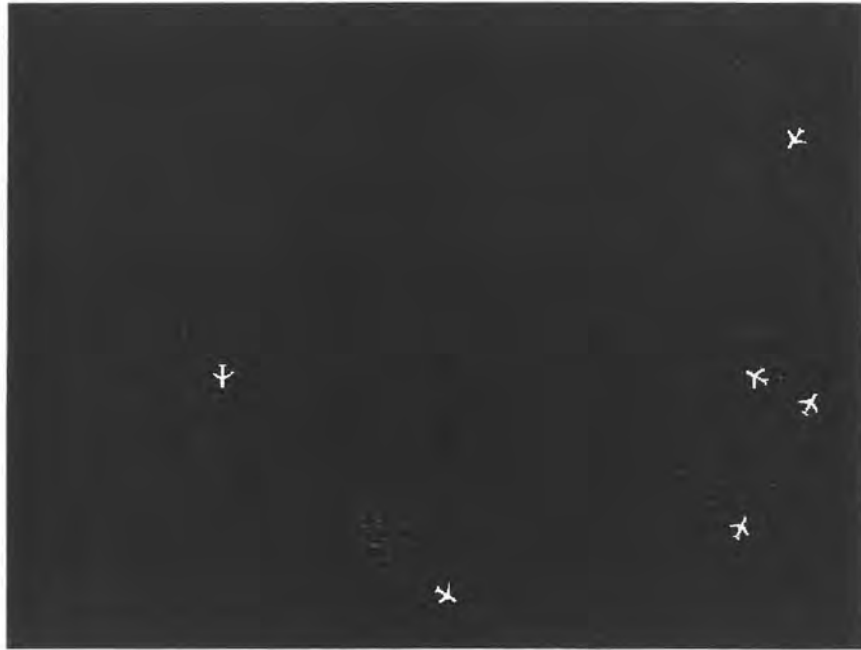
GJS6187 on about a 7 mile final RWY 22R (10/13/2015)
(ASQ5366 turning from TWY Alpha to TWY Quebec)

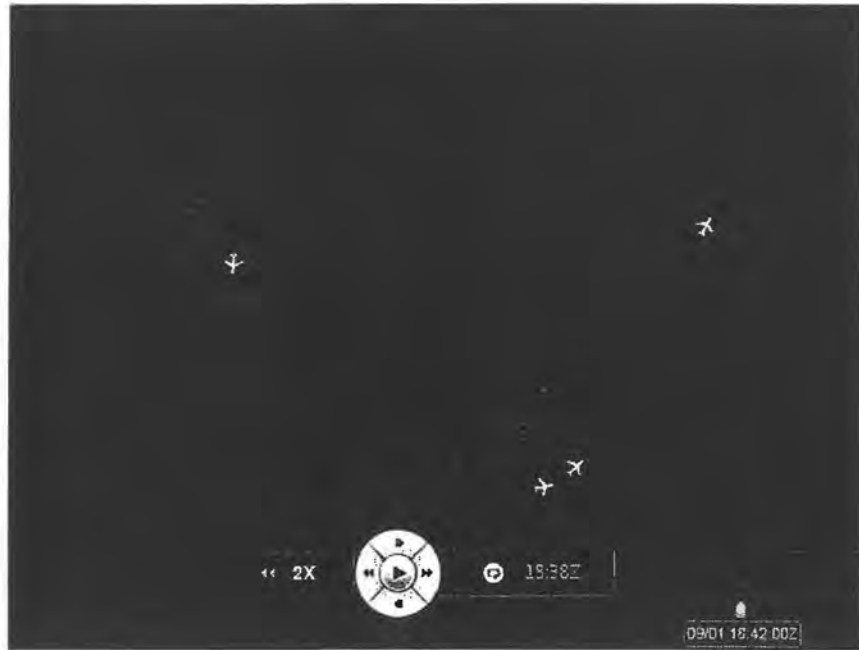
SKW7402 REPORTED FLUCTUATIONS WITH THE RWY 22R ILS "Y" LOCALIZER

SKW7402 on about a 12-13 mile final RWY 22R (09/01/2015)
(FLG3870, CRJ9 turning form TWY Alpha to TWY Quebec)

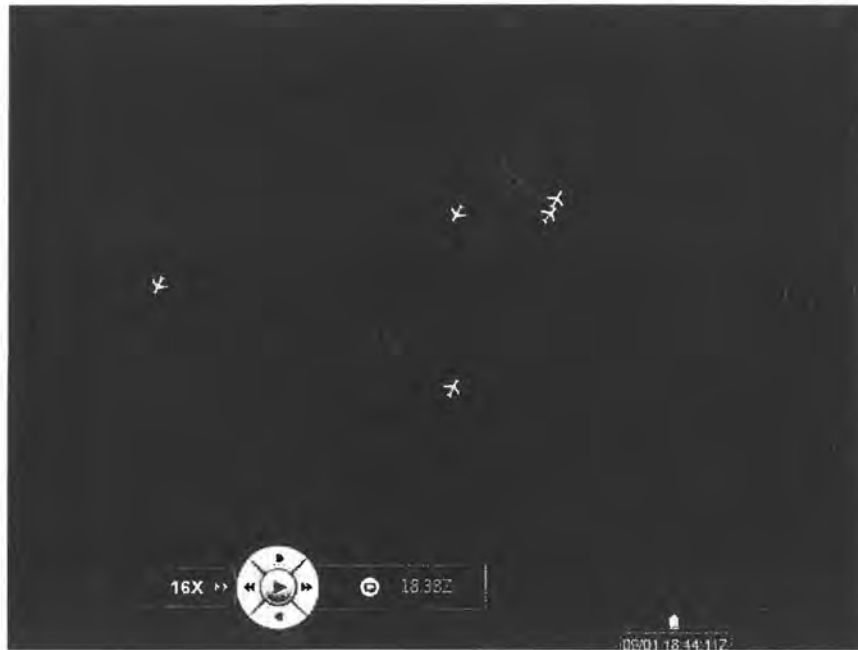
SKW7402 on about a 6-7 mile final RWY 22R (09/01/2015)
(DAL2082, B712 turning from TWY Alpha to TWY Quebec)

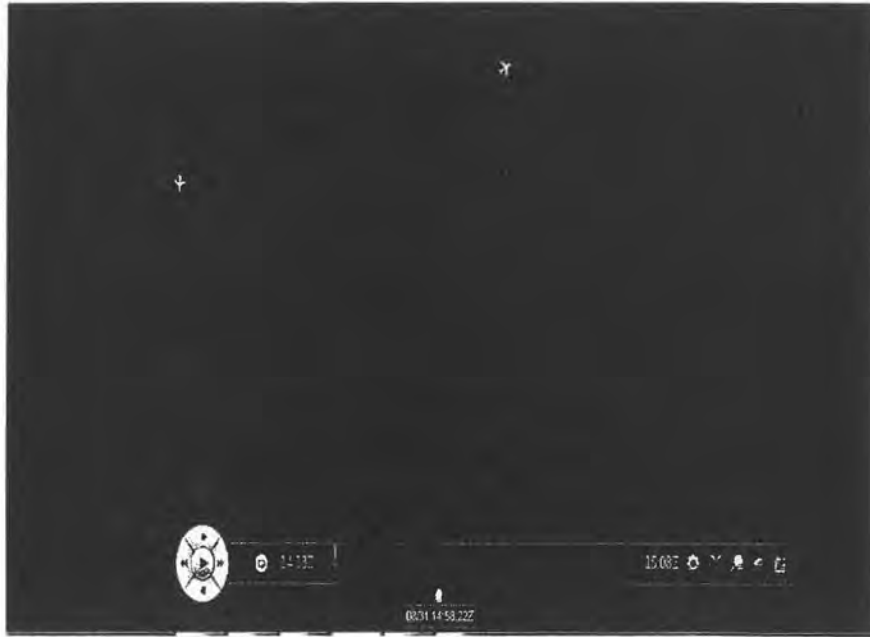
**TCF3313 REPORTED FLUCTUATIONS WITH THE RWY 22R ILS "Y"
DURING PRM APPROACHES.**

TCF3313 on about a 8-10 mile final RWY 22R (08/31/2015)
(SKW4493, CRJ2 turning from TWY Alpha to TWY Quebec)

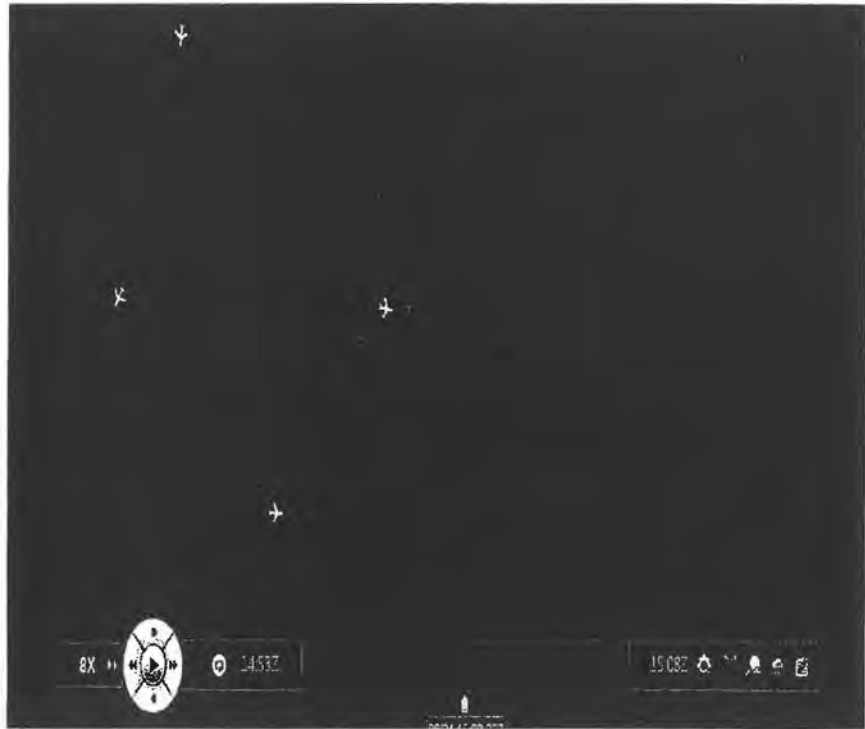
**SKW4656 REPORTED FLUCTUATIONS WITH THE RWY 22R ILS "Y"
DURING PRM APPROACHES.**

SKW4656 on about 8-10 mile final RWY 22R (08/31/2015)
(TCF3322, E145 turning from TWY Alpha To TWY Quebec)

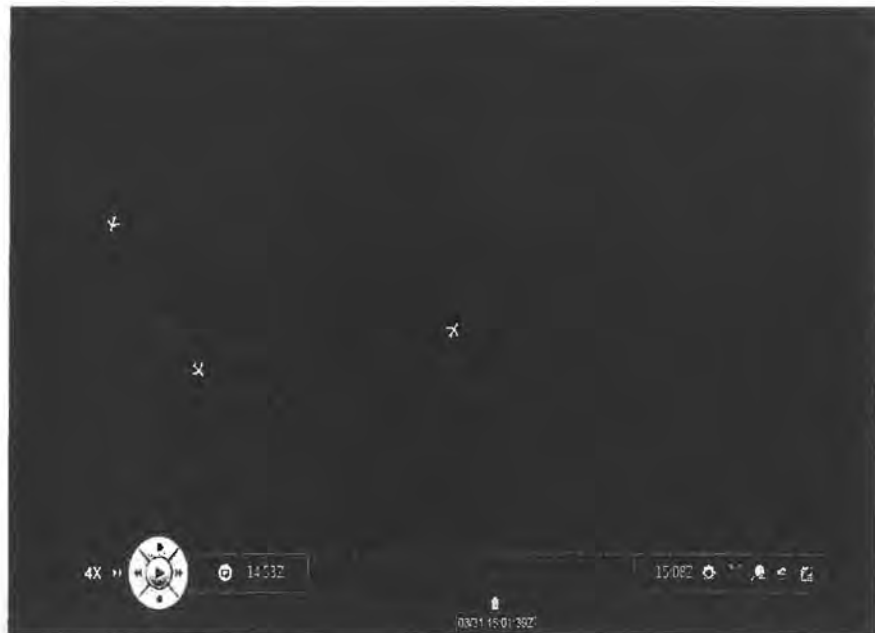
SKW4656 on about 5 mile final RWY 22R (08/31/2015)
(DAL2851, A319 turning from TWY Alpha to TWY Quebec)

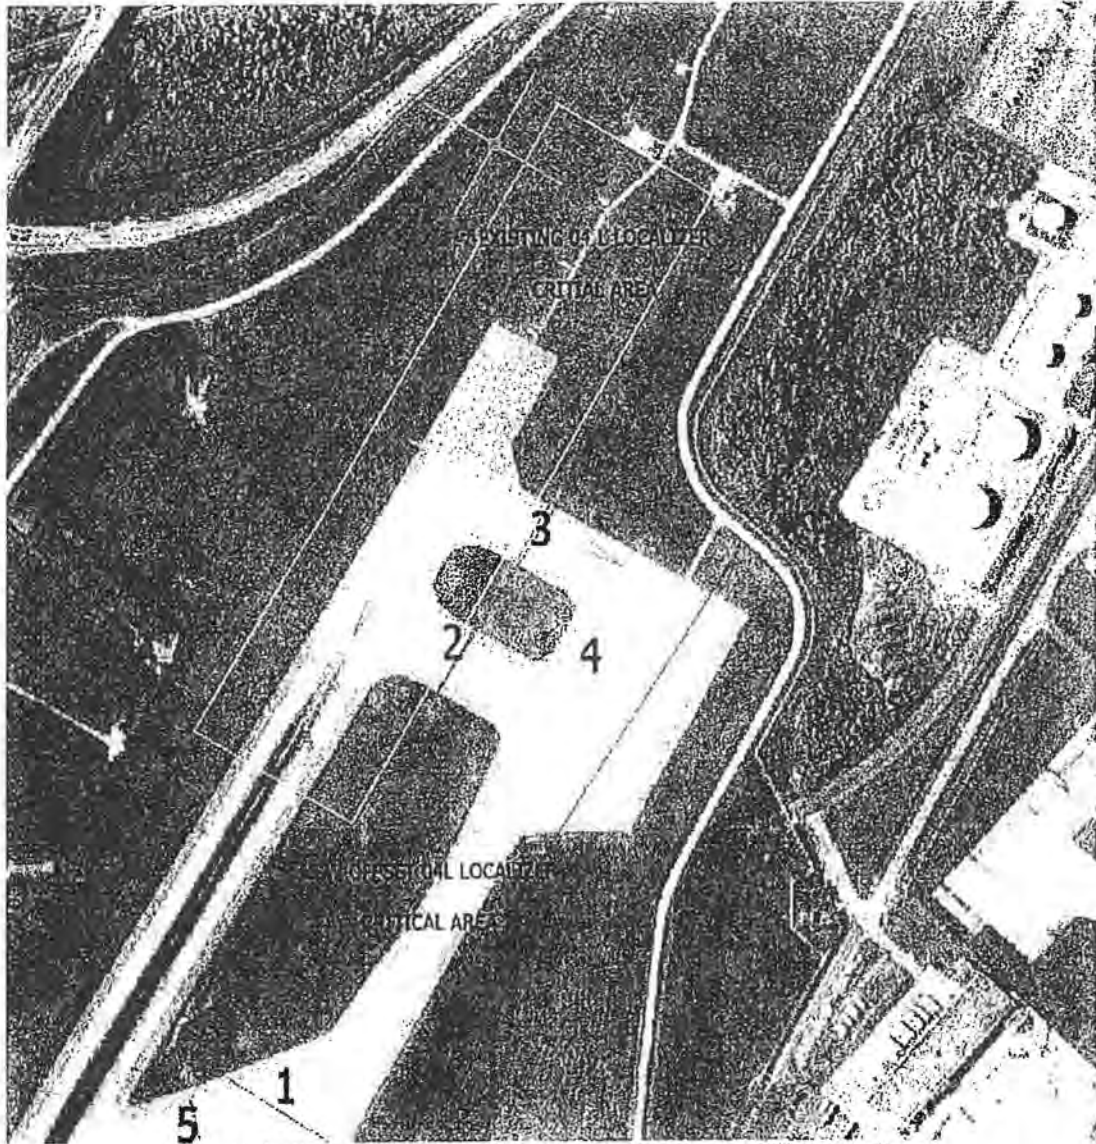
Figure 2. Runway 04L Critical Area of the 2.5-Degree Offset Localizer

The 2.5-degree offset localizer critical area will be penetrated by aircraft on taxiways "A-8", "A-9" and "A-10".

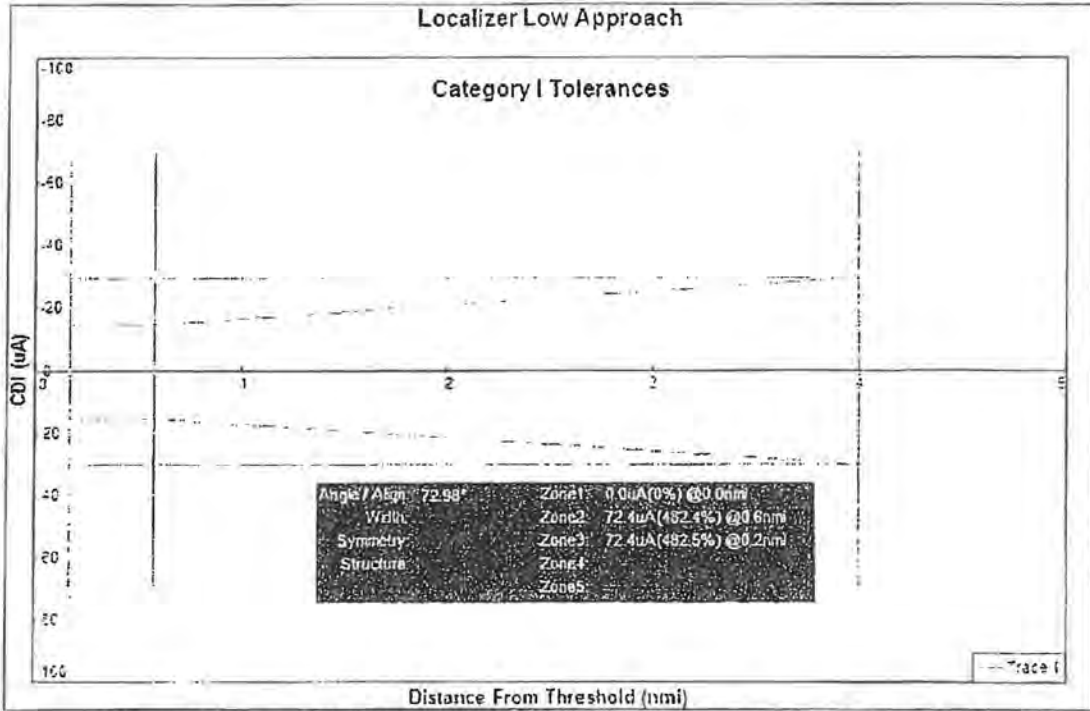
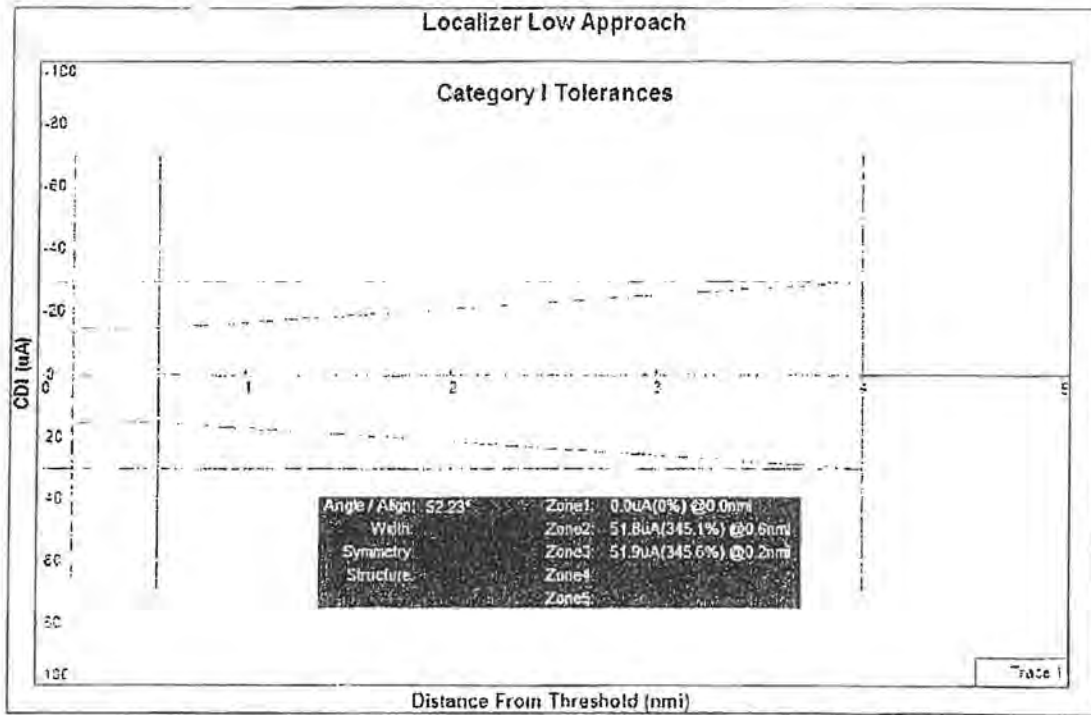
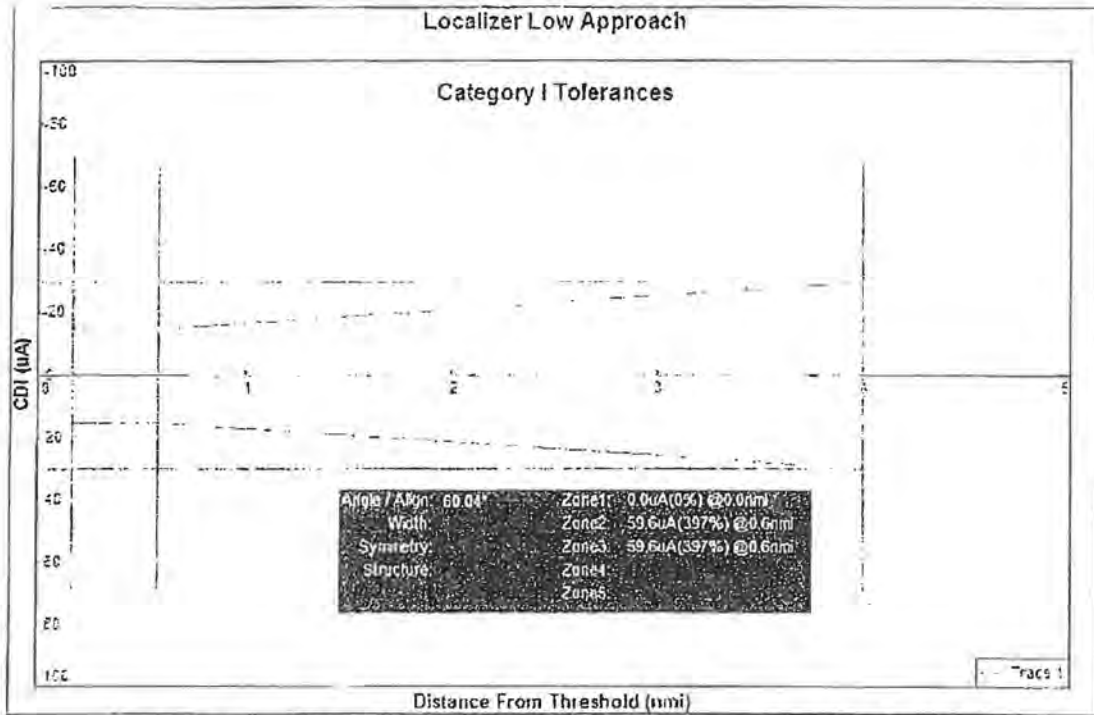
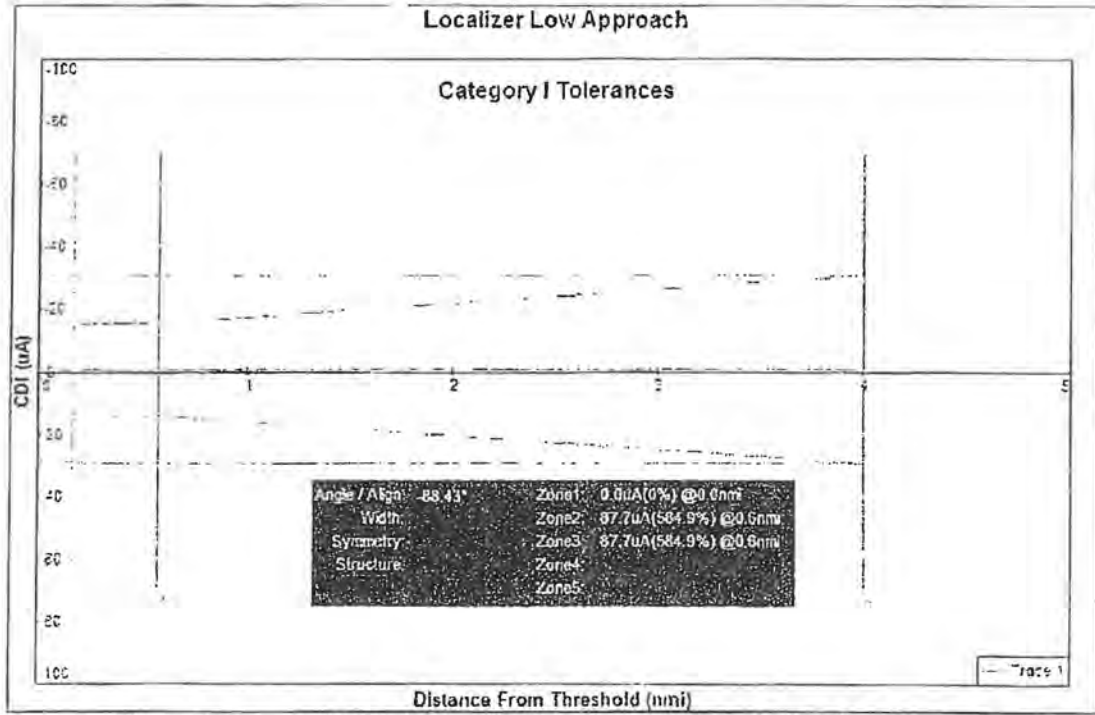
Simulation results show that there are significant effects from aircraft at location 2 through 5 on the performance of the runway 04L localizer. The results also show that group 1 and 2 aircraft located at position 1 will have minimal impact on the performance of the offset 04L localizer.

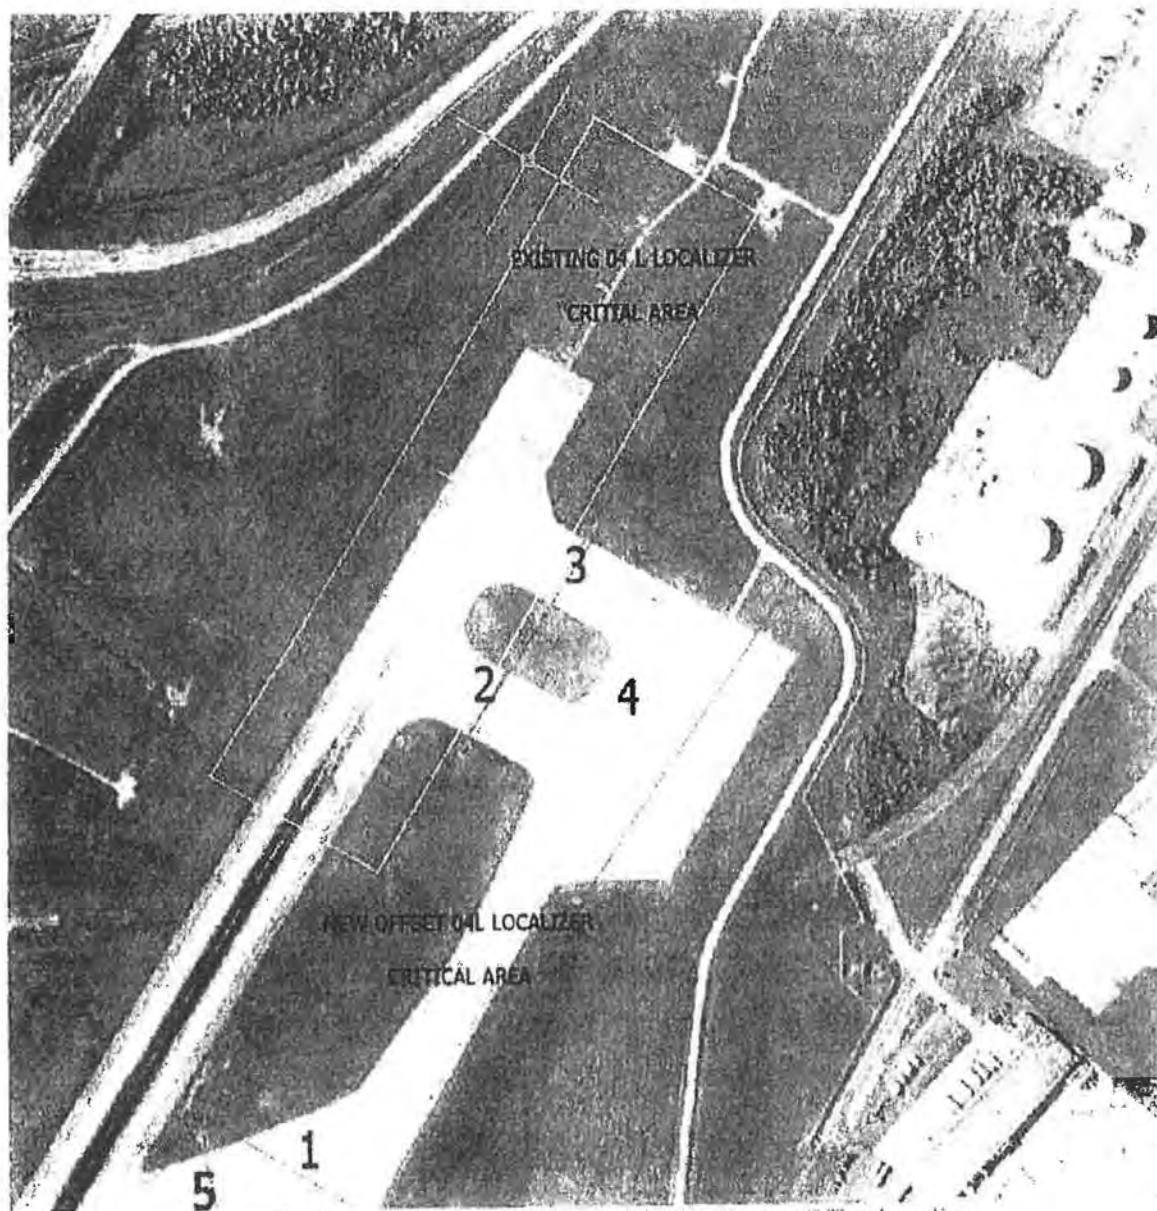
Figure 2. Runway 04L Critical Area of the 2.5-Degree Offset Localizer

The 2.5-degree offset localizer critical area will be penetrated by aircraft on taxiways "A-8", "A-9" and "A-10".

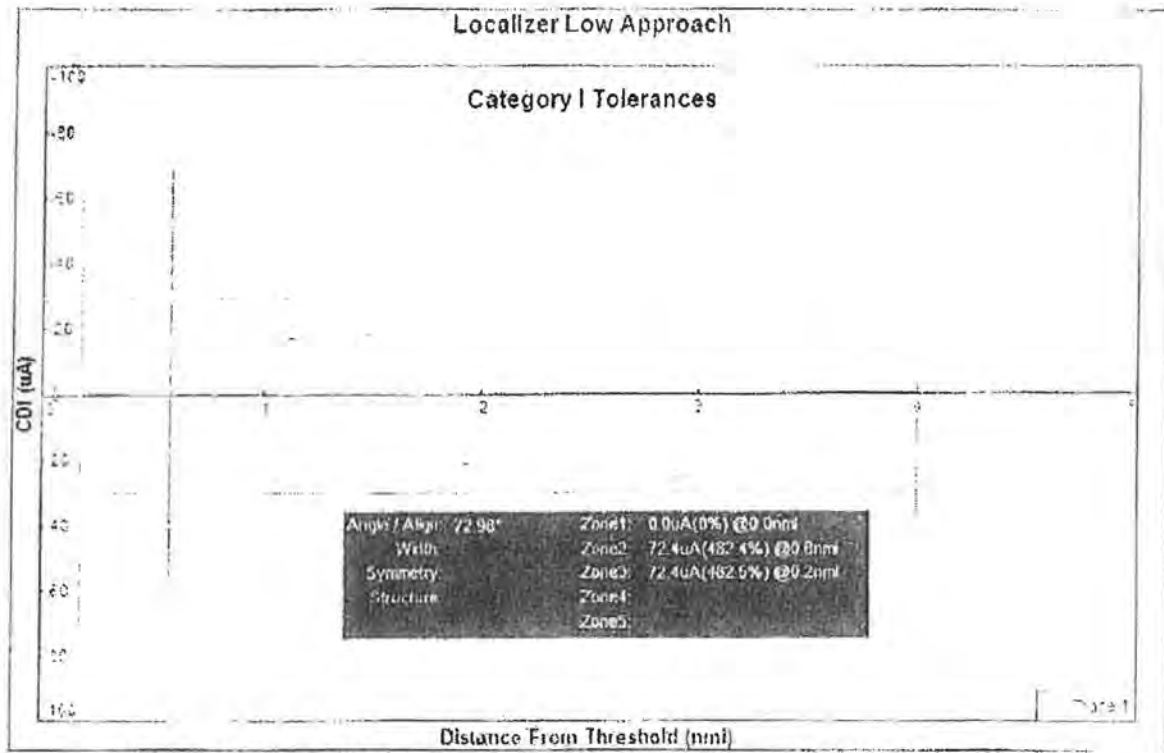
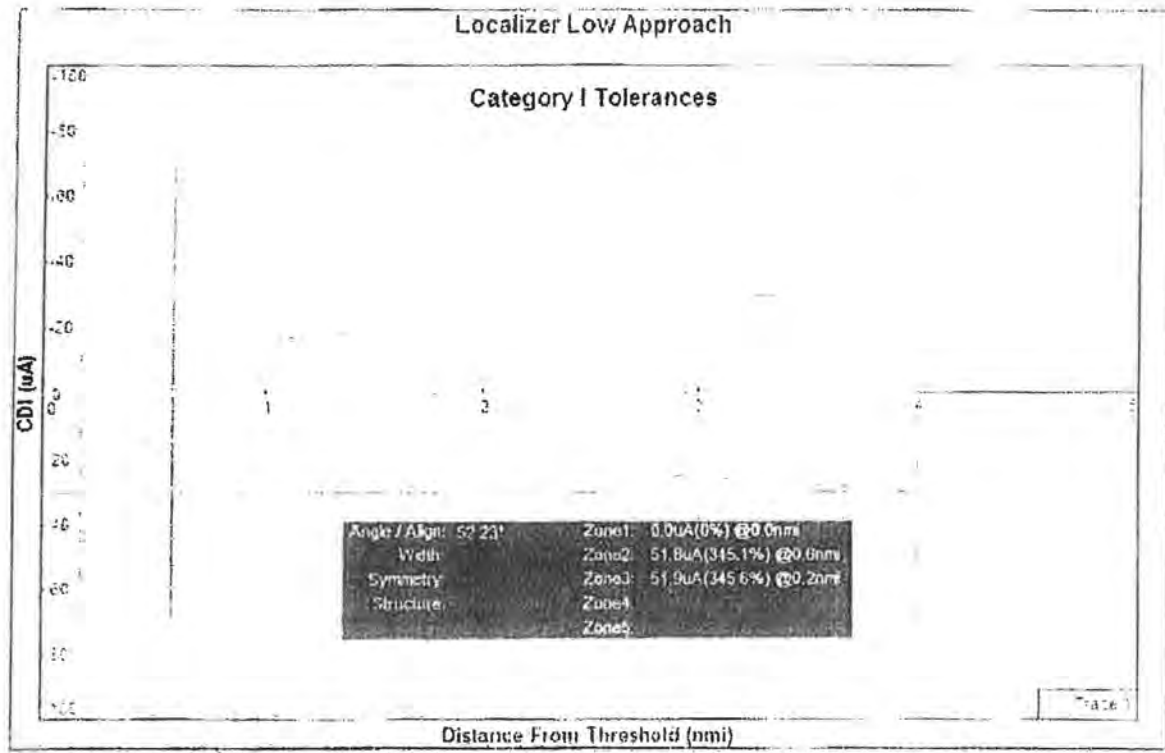
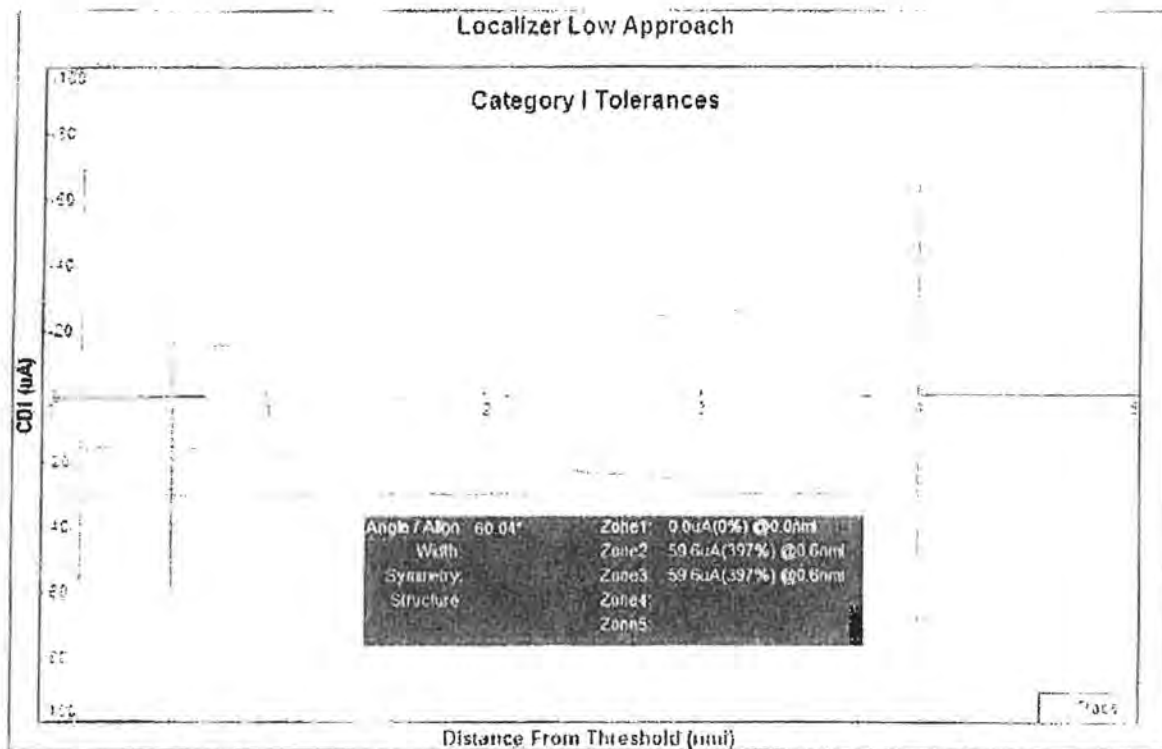
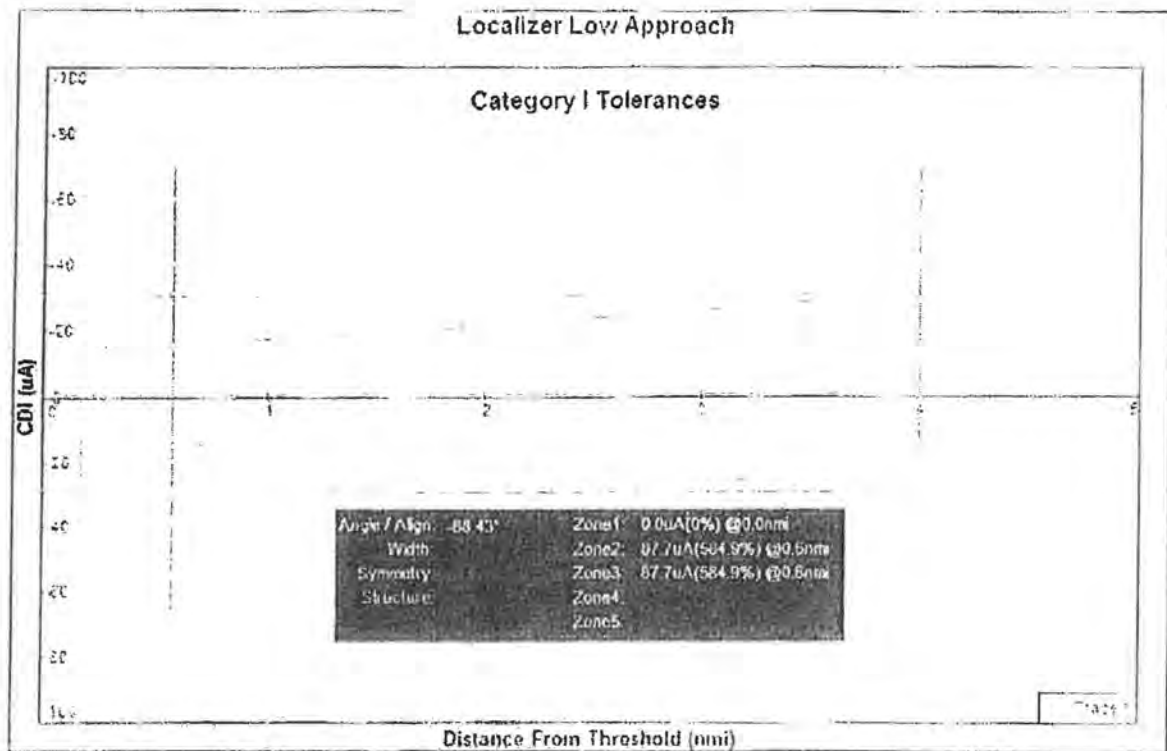
Simulation results show that there are significant effects from aircraft at location 2 through 5 on the performance of the runway 04L localizer. The results also show that group 1 and 2 aircraft located at position 1 will have minimal impact on the performance of the offset 04L localizer.
