**Final Independent Engineering Expert Opinion  
Report for the U.S. Office of Special Counsel (OSC)  
on Hydraulic Pumping Equipment Related to  
Three Major Flood Protection Structures in New  
Orleans**

*Covering Contract 20080028 OSC-MGT-045-2008 - Scope C-3 (Only)*

*20 May 2009*

**APARIQ, Inc.  
7300 Olive Tree Court  
Gaithersburg, MD 20879**

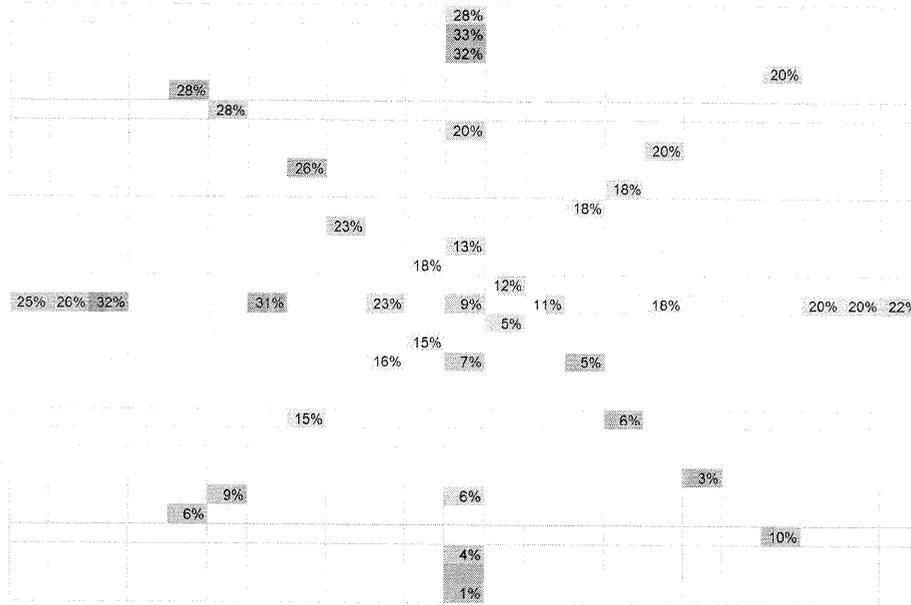
Figure 5 - Cross-section (across test piping) of Percentage of Maximum Observed Flow Measurements from Flow Test 4-7 Data

The information shown in Figure 5 portrays a 38% flow differential across the measurement cross section, and this type of flow differential can be caused by flow imbalances and cavitation and most certainly leads to inaccurate flow representations, especially when all of the measurement cannot be taken at the same time.

The bearings in the water pumps should be inspected for damage because of these turbulent observations, as well as inspecting the pump impeller for cavitation damage.

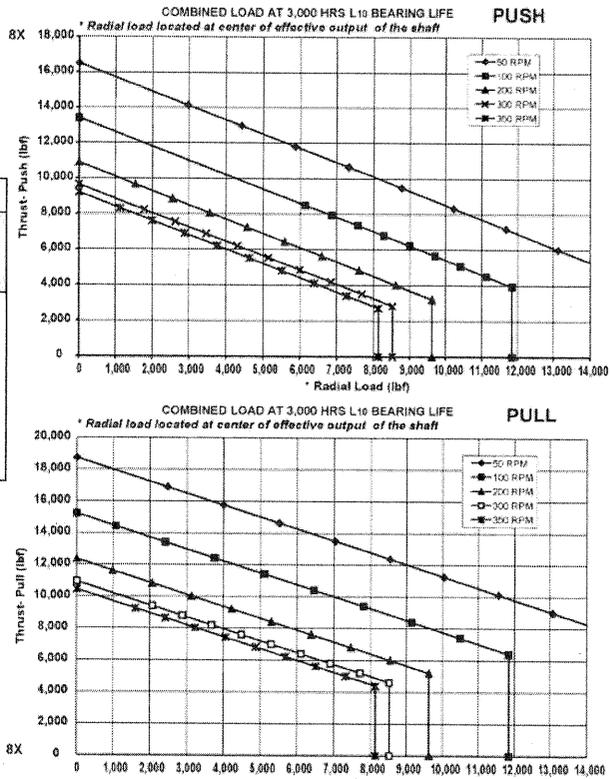
Figure 7 - Combined L10 Graphs from Rineer

2. DRAINAGE PUMP (Page 7 of 32)		
Section	Solicitation and MWI Contract Requirement	Requirement Met?
2.2.3	The shaft bearing shall be sealed, self-lubricating by low pressure hydraulic oil designed for bearing life of 50,000 hours use.	"NO" - Bearing life from Rineer was not designed for more than 3,000 L10 hours of use.

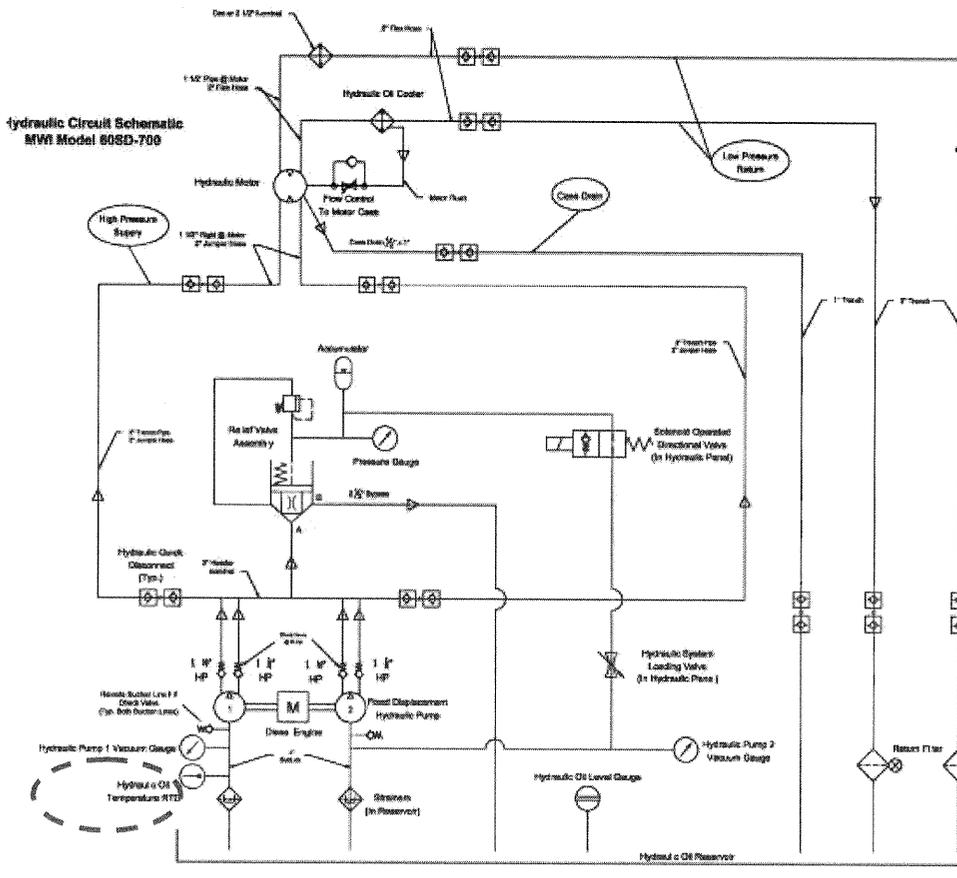
Figure 9 - Hydraulic Oil Temperature Sensor in Wrong Location

The temperature sensor for the hydraulic oil temperature was located upstream of the discharge of the Denison hydraulic motor.

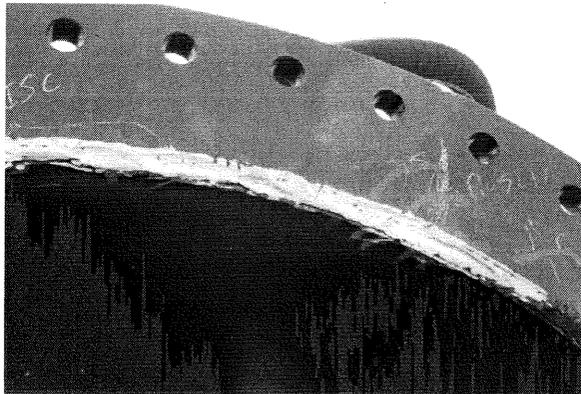
Figure 10 - Poorly Coated Part

2. DRAINAGE PUMP (Page 7 of 32)		
Section	Solicitation and MWI Contract Requirement	Requirement Met?
2.2.5	The complete pump assembly shall be sand blasted to near white and painted inside and out with black bitumastic enamel equal to Zophar triple A or with Porter Taset epoxy or equal.	"NO" - Some pump assembly parts were not sand blasted and painted as required.

There are numerous pictures of exposed and uncoated parts of the pump system. Requirement 2.2.5 was not met.

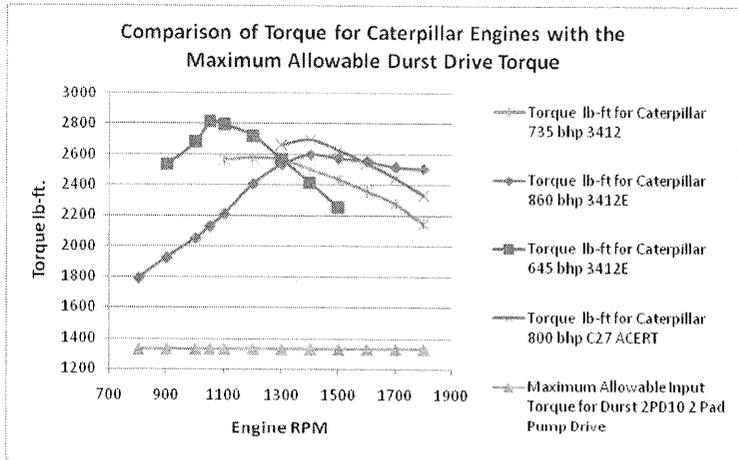
Figure 13 - Comparison of Caterpillar 3412 Engines Torques with the Maximum Allowable Durst 2DP10 2 Pad Pump Drive Torque

However, the maximum allowable torque, for the largest available clutch from Durst (the chosen vendor for the drive to connect the Caterpillar diesel engine to the Denison hydraulic pump, was only 1620 lb-ft and the maximum recommended engine horse power for the connected diesel engine was 308 hp. The Durst maximum allowable horse power of 308 is far below the USACE requirement of 735 hp.

No matter which equivalent Caterpillar 3412 (or follow-on C27 ACERT) engine was selected, the engine torque would have exceeded the maximum allowable torque and the maximum allowable horse power for any available Durst clutch (see torque values as shown in Figure 13).

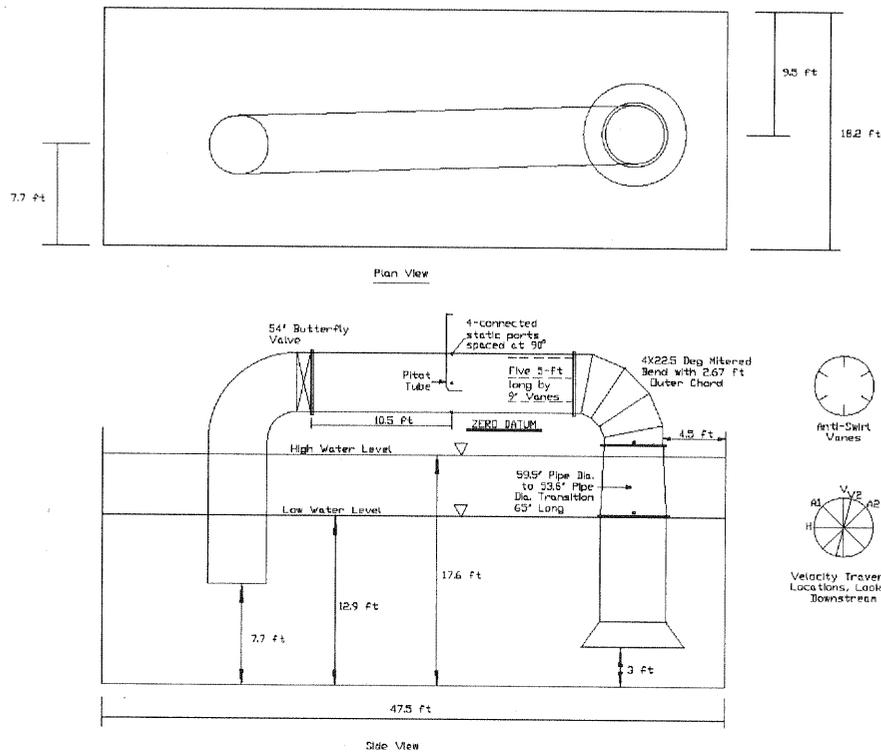
Figure 16 - Copy of Figure 2. Schematic of Test Flume from Factory Tests of MWI Pumps

The side view and top view of Figure 16 shown on page 58 of this document, clearly shows that the first condition, mentioned above, "a. Straight conduit upstream and downstream of the measurement location of 20 and 5 pipe diameters, respectively." was not met for the testing. The nominal pipe diameter described at the location of the Pitot tube was 53.6 inches (4.5 ft.), which would mean that the Pitot tube measuring point was just only slightly more than two (2) pipe diameters instead of the required upstream 20 pipe diameters.

The proximity of the 90° elbows shown in Figure 16, make it very difficult to conform to the second requirement mentioned above “b. Velocity distribution shall, as nearly as possible, be that of fully developed flow in a straight conduit, of uniform section.”

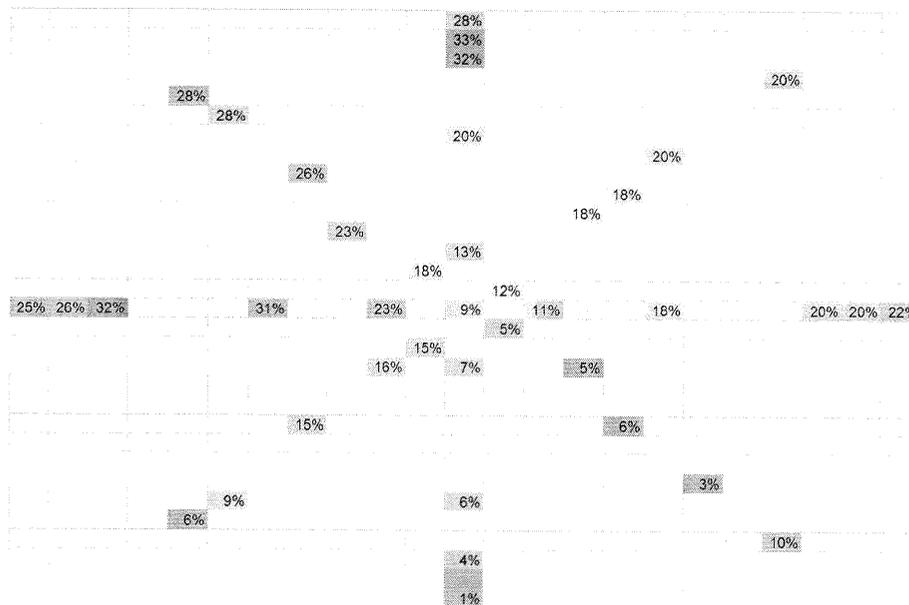
Figure 17 - Cross-section (across test piping) of Percentage of Maximum Observed Flow Measurements from Flow Test 4-7 Data

The information shown in Figure 17 documents nearly a 40% flow differential across the measurement cross section, and this type of flow differential can be caused by flow imbalances and cavitation and most certainly leads to inaccurate flow representations, especially when all of the measurement cannot be taken at the same time.

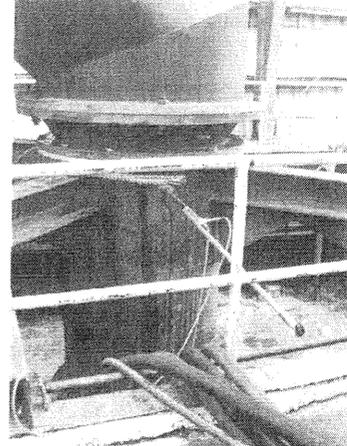
Pic. No. 15 - Unmarked pitot tube in the Discharge Pipe

"Pic. No. 15 - Unmarked pitot tube in the Discharge Pipe on 4/12/2006" is shown in Figure 19 clearly shows that MWI was attempting to conduct some sort of flow measurement test that was unacceptable by HIS standards, unless there was a hidden section of vertical piping between the test point and the pump that was at least 22-88 feet long (or the tank had to be more than 22-88 feet deep.

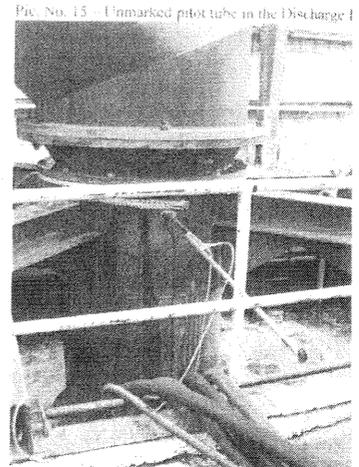
Figure 20

However, the suspended unit shown in "Pic. No. 7-Original testing apparatus-note size of testing tank (outline by yellow handrail) in relation..." Clearly shows that the distance between the outlet of the pump and the point where the measurement was being made in Figure 19 of this document was no more than three pipe diameters when it should have been 5 to 20 diameters. Therefore, any flow measurements did not conform to the requirements of Gen. engineering principles for using pitot tubes and most certainly did not conform to ASME document PTC 18-2002 or ASME PTC 18-1992.

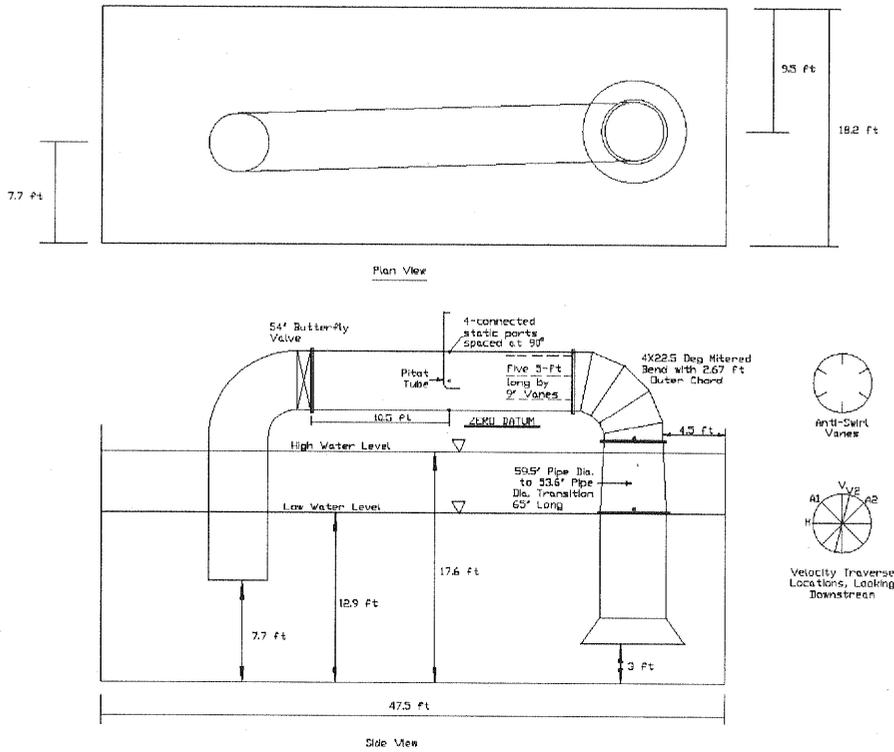
Figure 22 - Copy of Figure 2. Schematic of Test Flume from Factory Tests of MWI Pumps

The side view and top view of Figure 16 shown on page 58 of this document, clearly shows that the first condition, mentioned above, “a. Straight conduit upstream and downstream of the measurement location of 20 and 5 pipe diameters, respectively.” was not met for the testing. The nominal pipe diameter described at the location of the Pitot tube was 53.6 inches (4.5 ft.), which would mean that the Pitot tube measuring point was just only slightly more than two (2) pipe diameters instead of the required upstream 20 pipe diameters.

The proximity of the 90° elbows shown in Figure 16, make it very difficult to conform to the second requirement mentioned above “b. Velocity distribution shall, as nearly as possible, be that of fully developed flow in a straight conduit, of uniform section.”

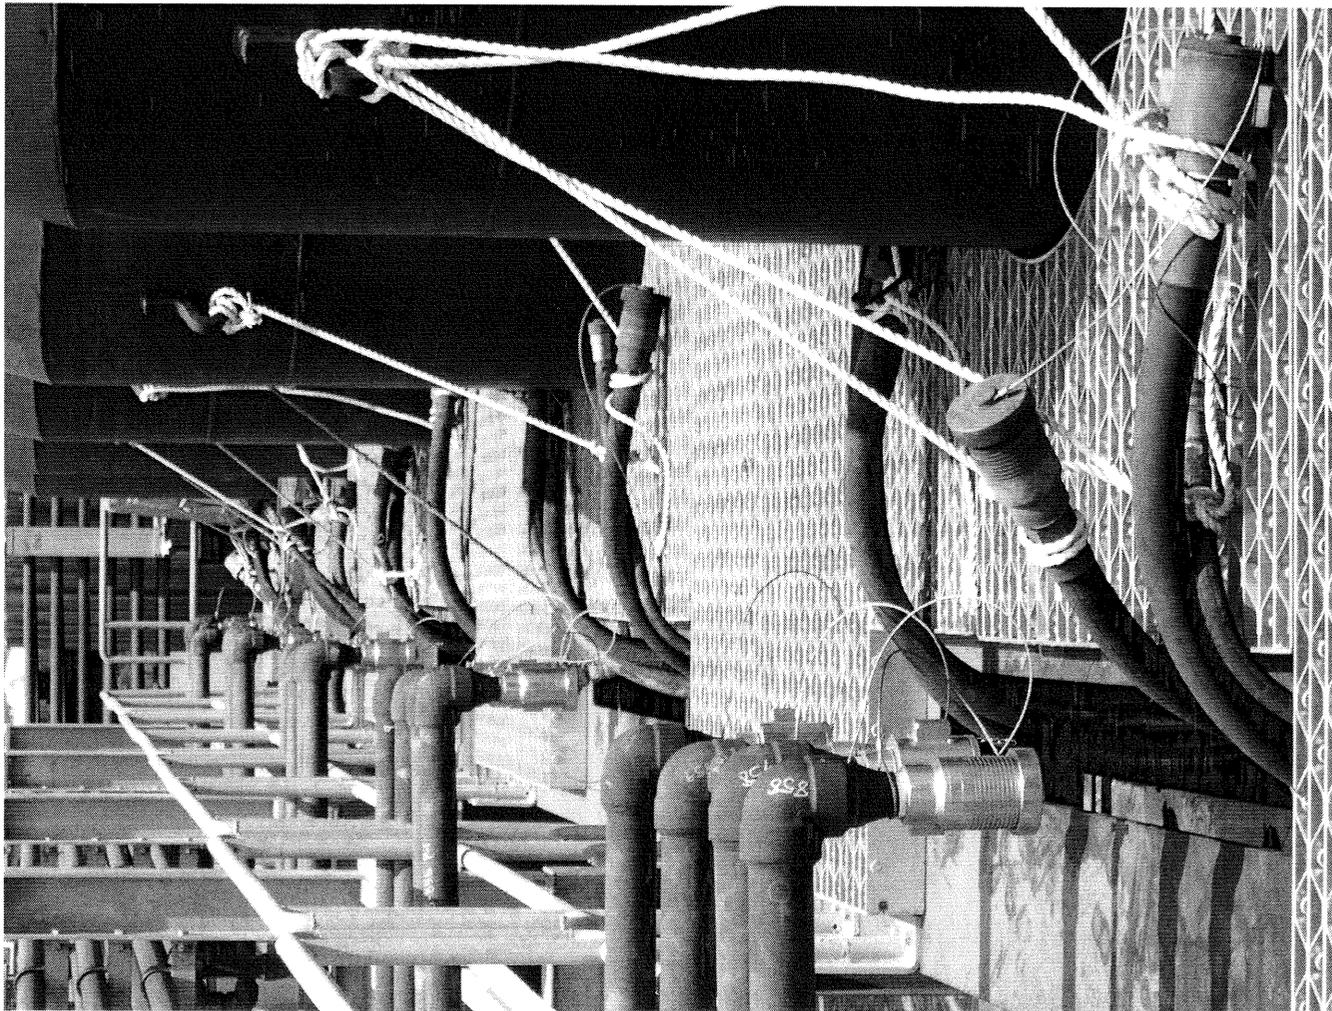
Figure 24 - Rusty Corroding Untreated Pipes and Components

*Also related to this issue: a reoccurring problem was documented in late June 2006 - thermal expansion of the hydraulic oil in the piping causing the oil to come up and out the fill cap in significant quantities (gallons). ..."*

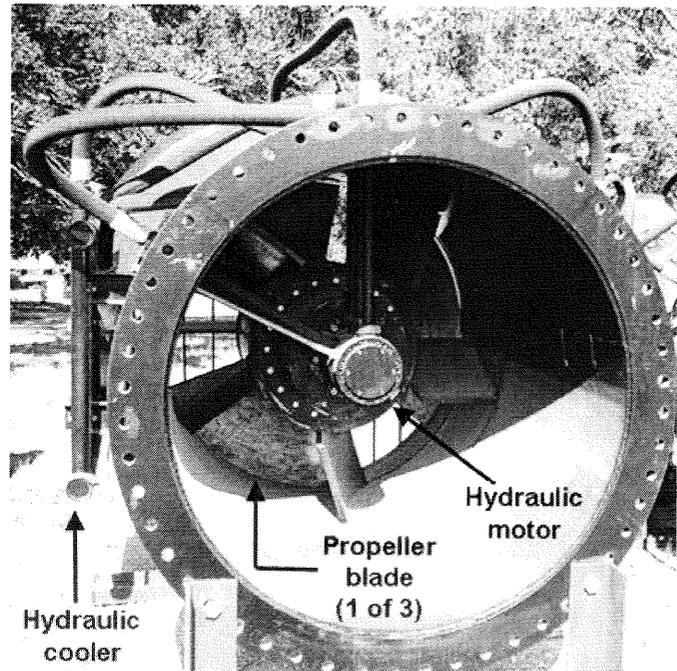
Figure 25 - Note Position of Oil Cooler

- **Hydraulic Oil Coolers were Either Undersized or Improperly Designed.** During testing there were many recorded events of very hot hydraulic oil and at least two instances the hydraulic hoses melted. If the hydraulic oil cooler were properly sized and properly designed the hydraulic oil should not have realized a temperature much higher than the temperature (<100° F) of the pumped water.
