**Final Independent Engineering Expert Opinion  
Report for the U.S. Office of Special Counsel (OSC)  
on Hydraulic Pumping Equipment Related to  
Three Major Flood Protection Structures in New  
Orleans**

*Covering Contract 20080028 OSC-MGT-045-2008 - Scope C-3 (Only)*

*20 May 2009*

**APARIQ, Inc.  
7300 Olive Tree Court  
Gaithersburg, MD 20879**

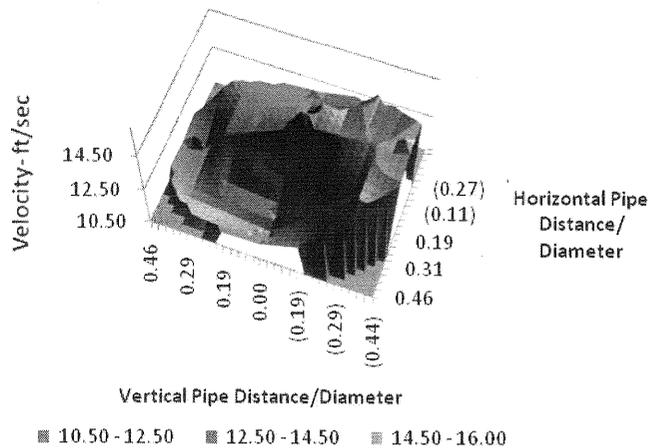
Figure 6 - Interpolated Representation from Flow Test 4-7

To help visualize the potential differences in flow rates across the pipe diameter, the data from the ERDC report for Flow Test 4-7 was plotted in a fashion similar to that shown in Figure 5 and the missing values were interpolated (filled in) to create the 3-D visualization of flow shown in Figure 6. This imbalance in flow is actually an imbalance in dynamic pressure and could potentially cause axial forces on the pump bearing to cause them to fail prematurely.

Unbalanced Non-Uniform Flow Rate from Factory Tests of Discharge and Total Dynamic Head of MWI Pumps  
Flow Test 4-7

The bearings in the water pumps should be inspected for damage because of these turbulent observations, as well as inspecting the pump impeller for cavitation damage.

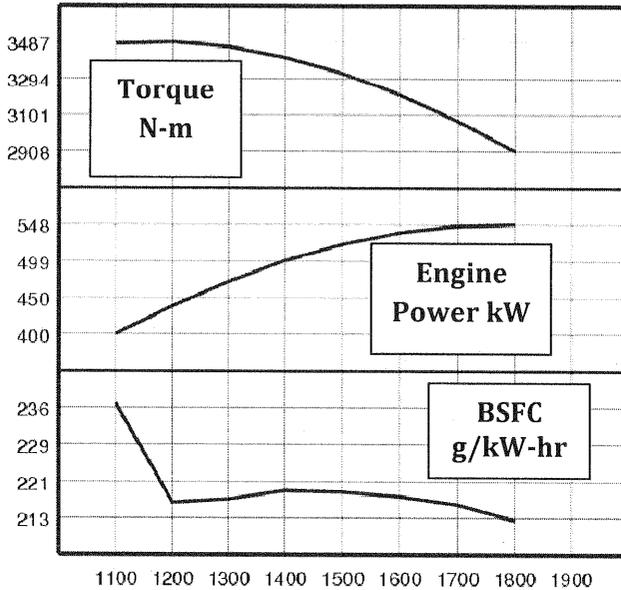
Figure 12 - Torque vs Engine RPM for Caterpillar 3412 Diesel Engine

**(Observation 2-D)** Torque on a diesel engine is higher at low RPM. Figure 12 shows that the torque on the Caterpillar 3412 Diesel Engine with 735 bhp delivers about 3476 Newton-meters (N-m) at 1100 rpm or 2564 ft-lbf.

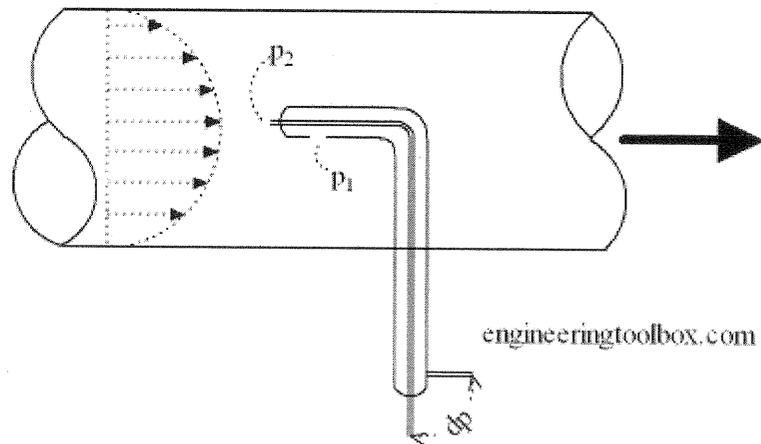
*The use of the pitot tubes shown in the "Pic. No. 15 – Marked pitot tube..." could not have provided accurate flow measurements, especially considering the less than full pipe discharge volume shown in "Pic. No. 16 – Test being run..."*

Averaging pitot tubes are most suitable for flow measurements of clean liquids, gases or steam. The devices are not the best choice, however, for multiphase fluids, such as a liquid with entrained gas or with high levels of cavitation (and turbulence) are not good applications for this technology.

Many of the engineering reference books, e.g. Process measurement and analysis<sup>30</sup>, require a straight pipe length of 5 to 25 pipe diameters between the upstream disturbances (in this case the pump

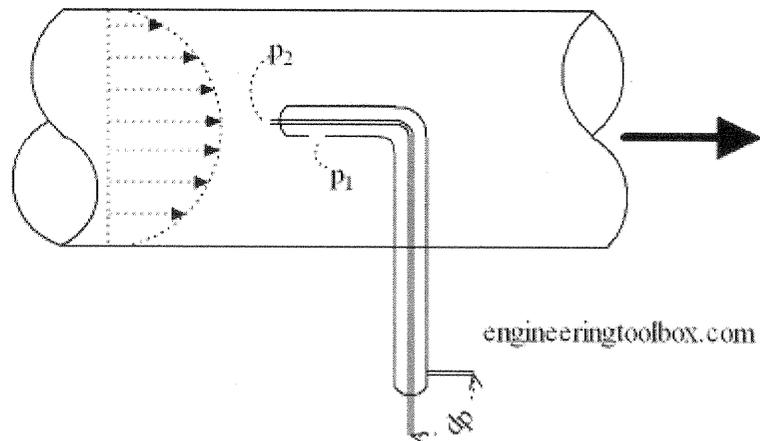
Many of the engineering reference books, e.g. Process measurement and analysis<sup>35</sup>, require a straight pipe

*The use of the pitot tubes shown in the "Pic. No. 15 - Marked pitot tube..." could not have provided accurate flow measurements, especially considering the less than full pipe discharge volume shown in "Pic. No. 16 - Test being run..."*

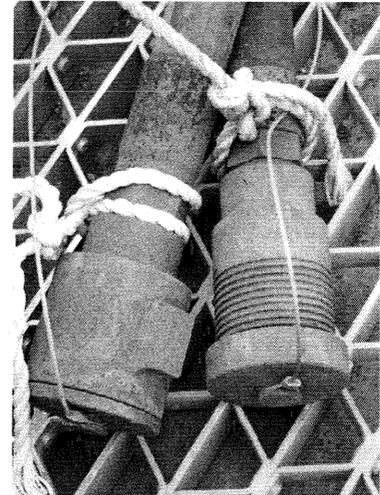
**Whistleblower Allegation #13:**  
The hydraulic piping supplied by the contractor is not in accordance with accepted industry standards.

APARIQ believes this allegation is valid.

In the ECM-GEC Joint Venture Report<sup>44</sup> dated 27 April 2007 the authors of that document clearly identified the following require coating protection against corrosion, "including the: ..., 2) hydraulic piping and pipe supports, 3) pump platform substructures, 4) discharge piping supports, 5) discharge piping internal surfaces, 6..."
